U S NAVAL PROVING GROUND  
DAHLGREN, VIRGINIA

REPORT NO 1136

62nd Partial Report

Test of Mk 77 Mod 0 Bomb (Fire-750 lbs.) with Canted Fins

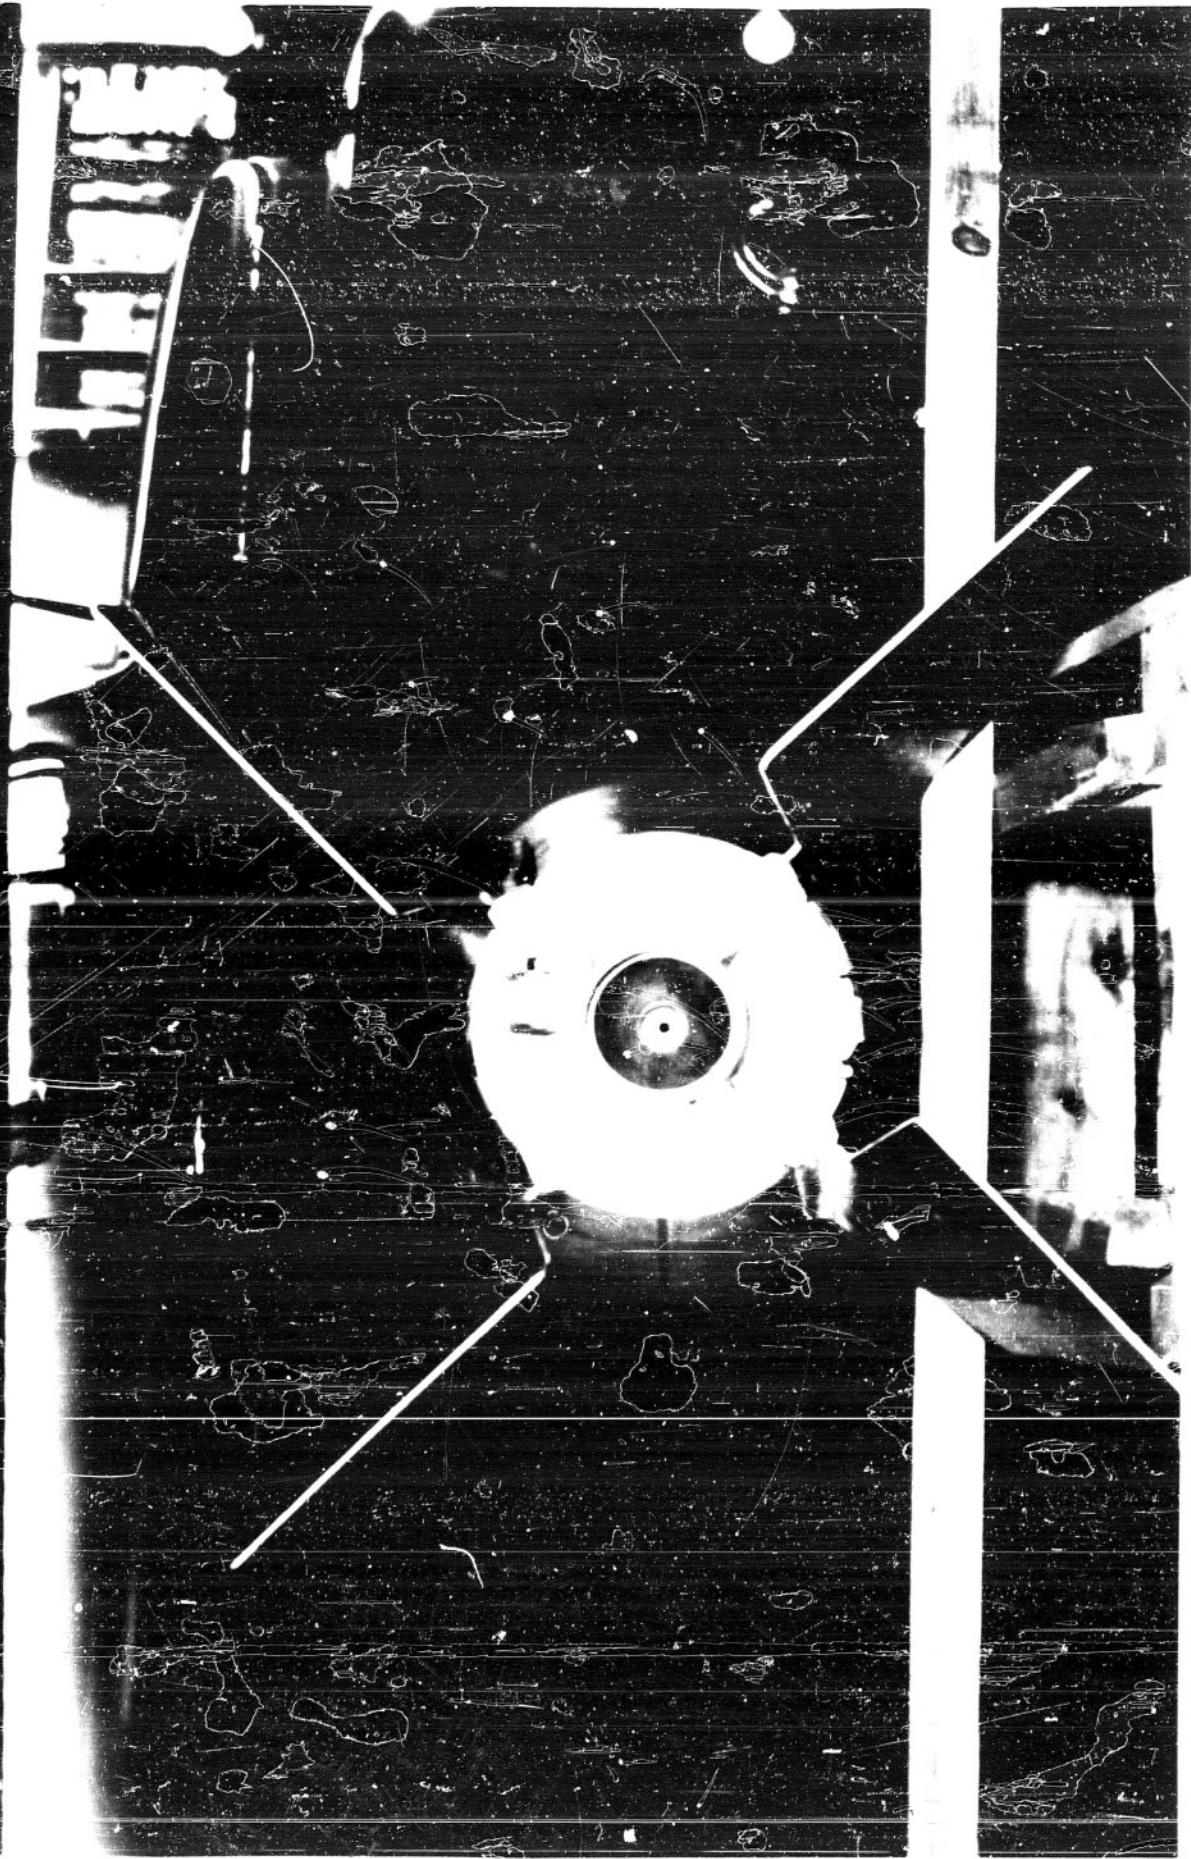
Mk 77 Mod 0 Fire Bomb, equipped with canted fins before modification, rear view.  
Figure 1

The bomb tested was a standard Mk 77 Mod 0 Bomb (Fire-750 lbs.) inert loaded and equipped with inert M23 Igniters and inert M173 Fuzes and further equipped with modified canted fins instead of the standard fins or fins and shrouds. The nose and tail cones were not installed. The fins are manufactured of ST aluminum, 3/16 inch in thickness and 18 inches in length along the root chord. The fins were welded at an angle to an adapter which bolted to the bomb. The angle of fin to the fore and aft centerline of the bomb, and to the adapter, is about 10 degrees. Actual measurements are given in Table I. Reference (c) authorized the modification of the fins as follows: The fins were strengthened by bolting a 3/8 inch steel rod 1-1/2 inches down and in from the outboard after corner of two (2) adjacent fins, and bolting rods between the next two (2) fins as close as practical to the bolts used in the first two (2) fins. Figures 1 through 4 show the bomb before and after modification.

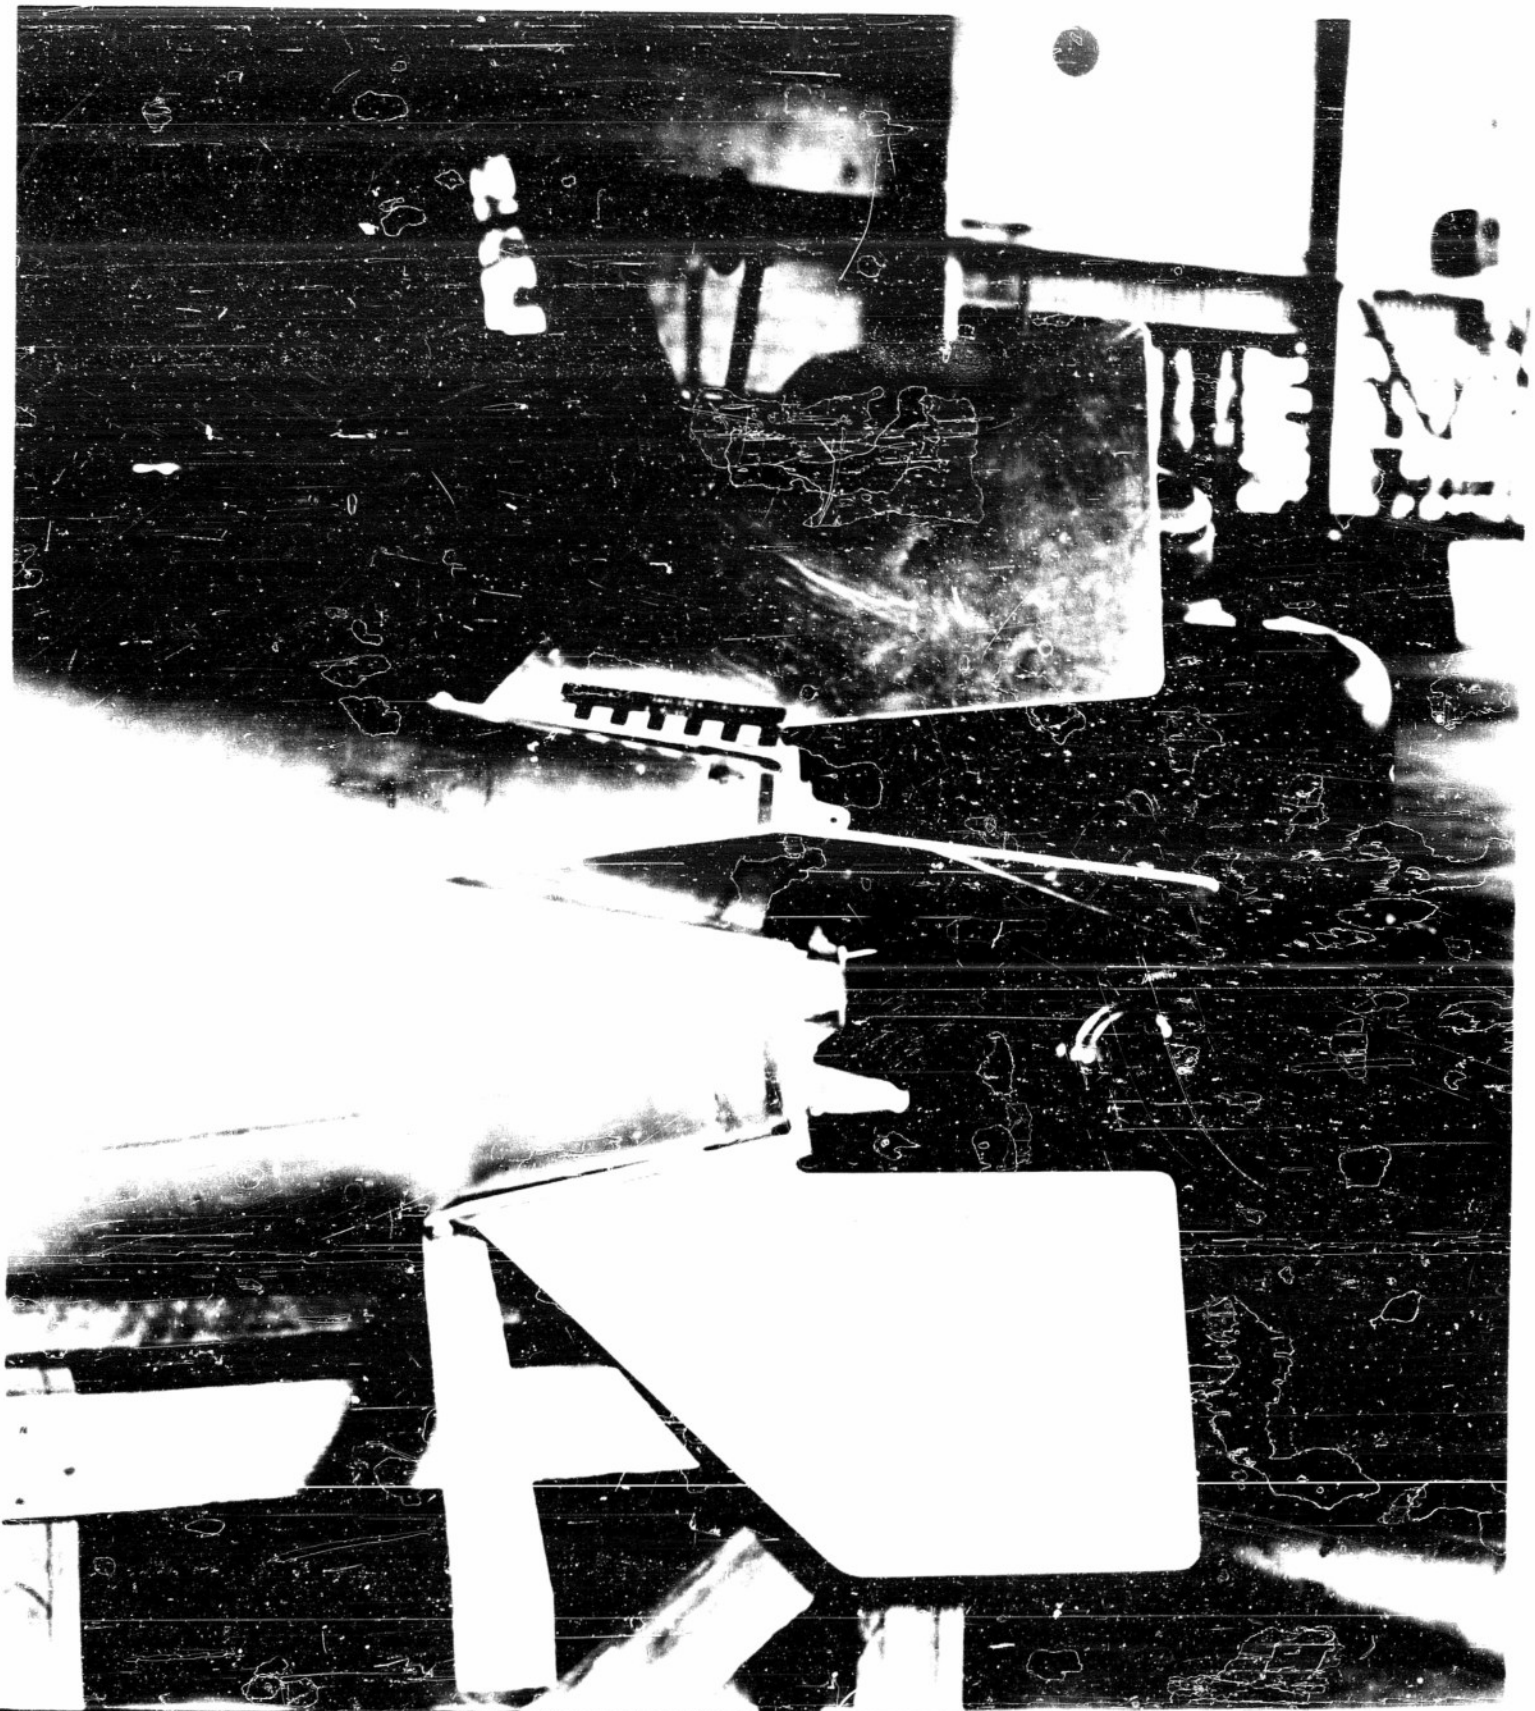
M7 Mod 0 Fire Bomb equipped with canted fins before modification,  
side view. Figure 2

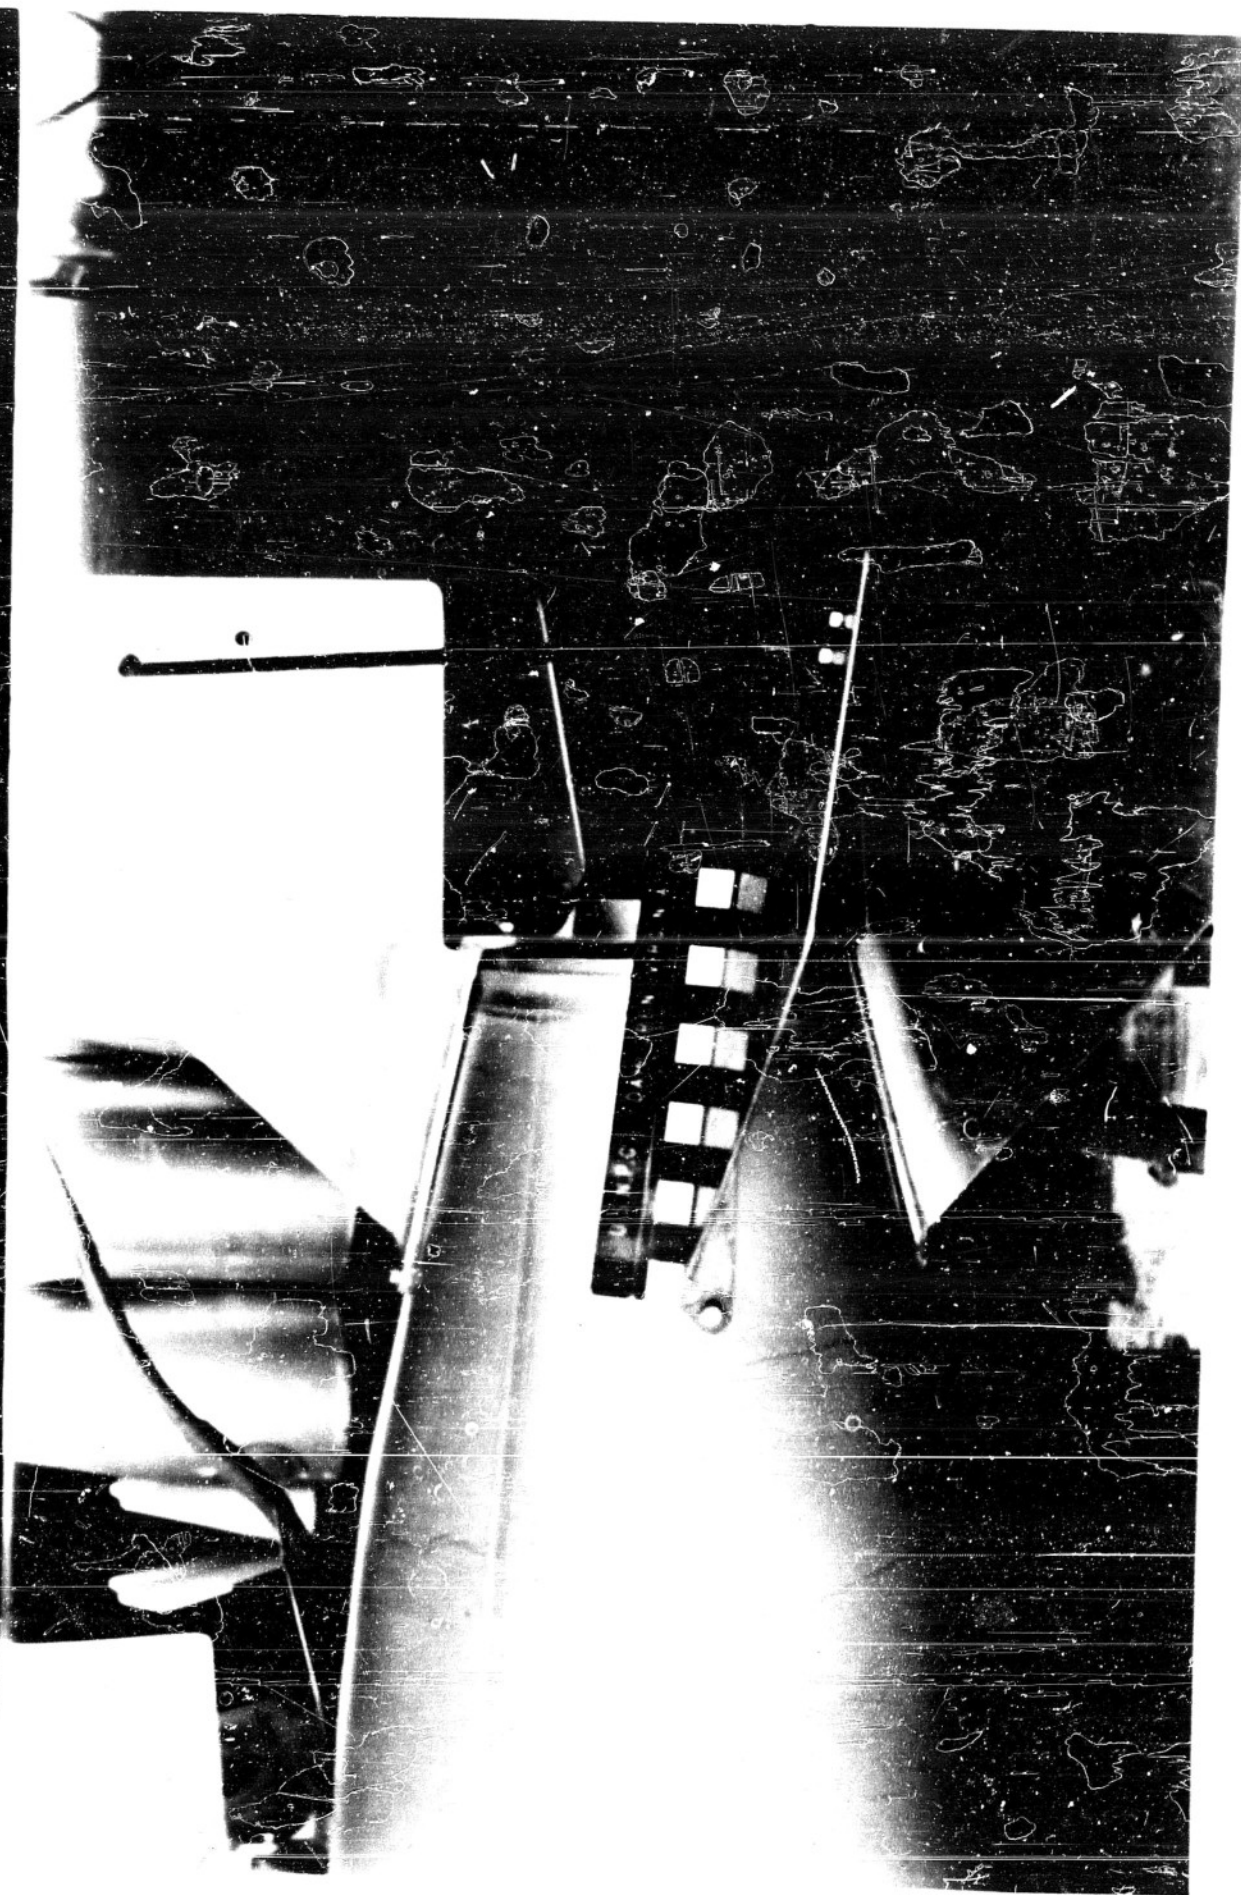
Figure 3

EX 77 Mod O Fire Bomb equipped with canted fins, after modification, side view.

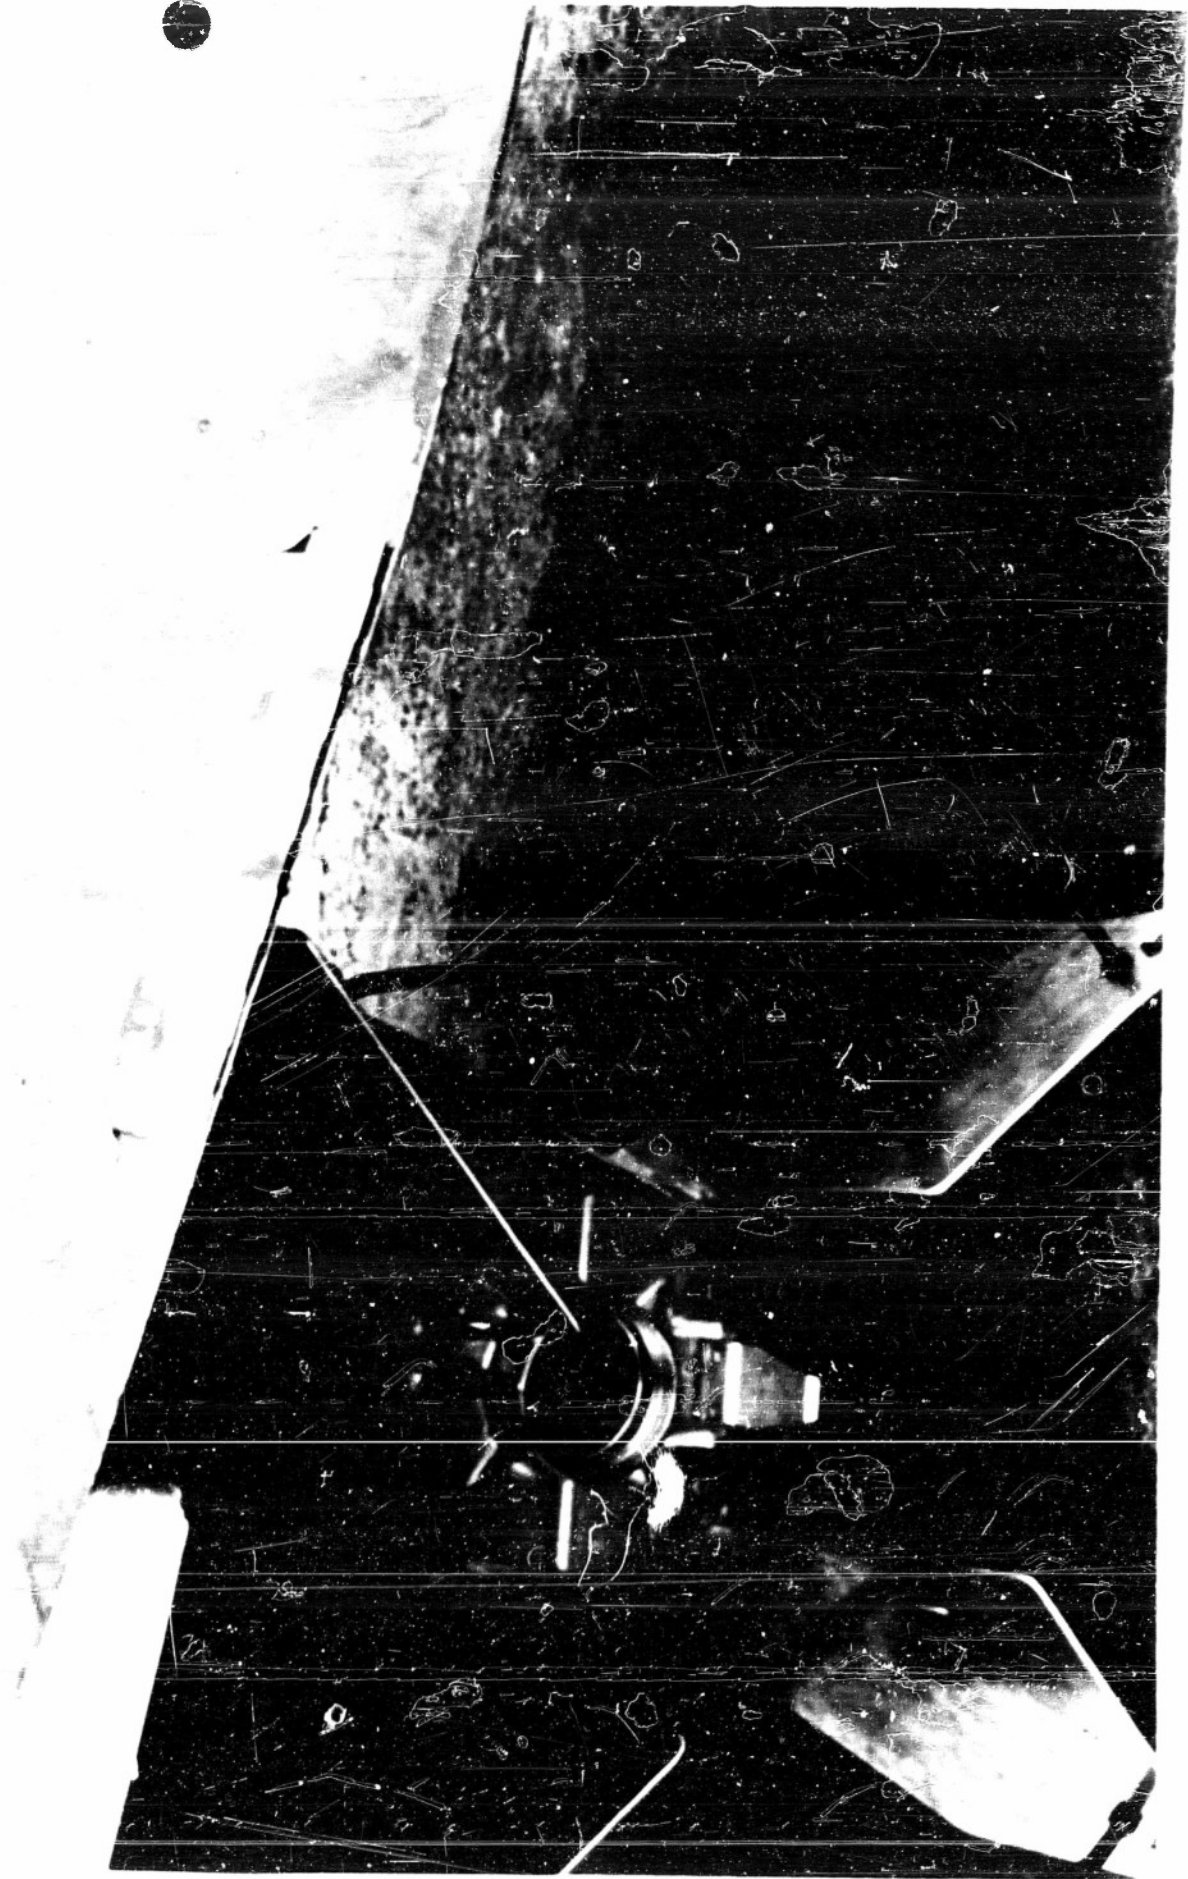
7 April 1953  
Figure 6

NP9-631137  
Mx 77 Mod C Fire Bomb with canted fins  
bare clearance.

RESTRICTED  
SECURITY INFORMATION  
F4U-5, flaps down 20°
